## SINKING PATIOS

Project: #10701

Location: Louisville, Kentucky

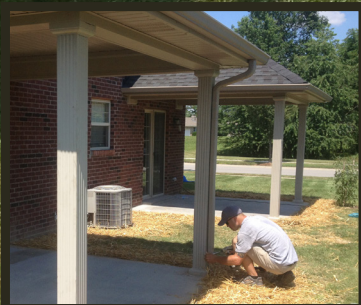
Two previous repairs had been made to the two patios of this condo. Those repairs proved to be unsuccessful, as the concrete continued to break and the posts holding the roofs continued to sink into the poor soil. The homeowners association wanted to be sure that this would be the final repair.

Demolition began early, jack hammering the existing concrete patios. Temporary beams and posts were brought in to take the load off the existing posts for removal. The poor soils were traded for gravel and were compacted with a vibratory plate compactor. 10" thickened edges with 140' of  $\frac{1}{2}$ " steel reinforcement was tied and pinned to the condo to prevent future settlement. Four, 2  $\frac{7}{8}$ " round shaft, 8/10" helical piers were installed to a depth of approx. 14', providing a bearing

capacity in excess of 30kips, which supported the 3kip roof load. A new construction cap was installed to the top of the piers and the steel reinforcement was tied to the pier cap. 5CY of 4000PSI concrete was poured with a brushed finish. We returned the next day to wreck forms, finish grade and seed/straw. The customer was thrilled with our efficient, thorough operation. They were also very glad that this is the last time they will have to address these plagued patios.
