2018-2019
**Horseshoe Casino
Retaining Wall Project**

Innovative Piering was contracted as a design-build contractor to address a failure of an existing sheet pile wall. The sheet pile wall was originally constructed in 1997 (cir.) and experienced a total failure in early 2018. The failed retaining wall supported site soils and a trucking/loading dock area. When the wall was first visited, it showed signs of significant lateral movement, in the direction of the river (south). This was documented by photos and showed movement in excess of 13" where the concrete met the sheet pile wall. Also noted was the ejection of the existing tension ties/micropile bars. Some of which remained in suspension on the existing waler beam, others were ejected into the river.

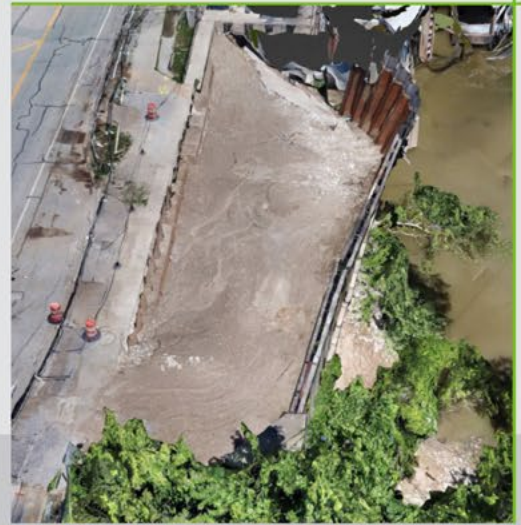
This lateral deflection created a hazardous condition forcing the total closure of the dock area. It also made for difficult demolition. Once the area was made safer, a geotechnical drill was sent in to collect soil information and provide the basis for our design solution.

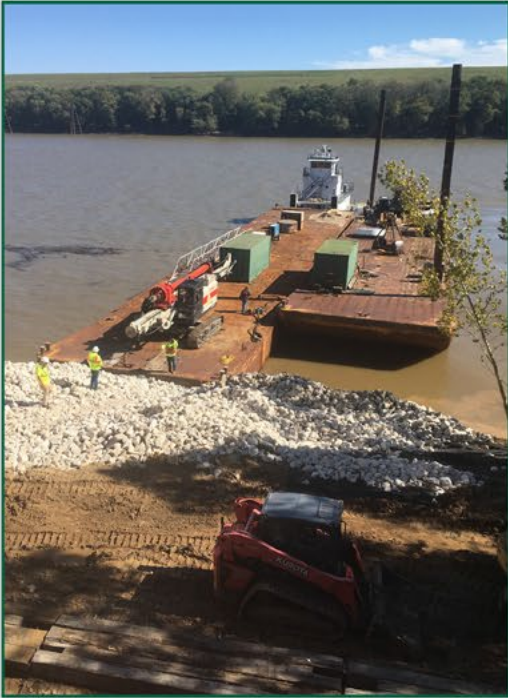
This phase included selective demolition and disposal of the steel and site soils. The site soils were mostly used to balance the erosion that had scoured the area outside of the sheet pile wall. The steel had to be cut out and removed via crane. Once up to the roadway, the scrap steel was loaded into semi-trailers and hauled to a local scrap yard. As more steel was removed, more soils were able to be pushed into the voided 'beach' bringing the grade to its previous grade prior to the scour. Majority of the soils balanced was a sand and clay mix.

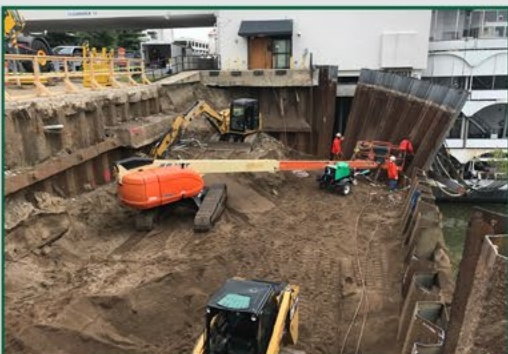
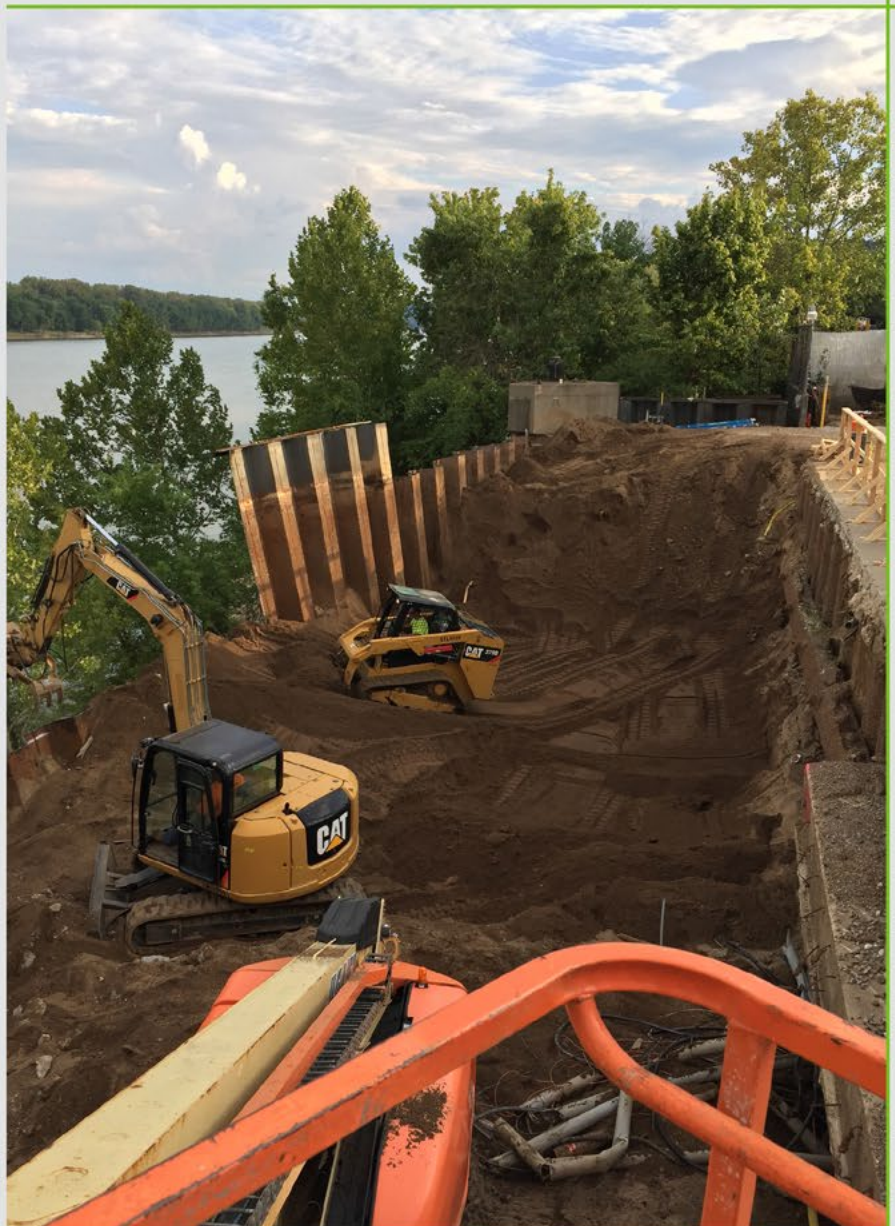
Another part of the project included importing barge loads of crushed stone to help prevent future scour of this beach. Therefore, once the soils filled in the eroded bank of the river, a fabric was laid over the soft soils, and capped with 12-18" crushed limestone. Due to the next phases of this project, we imported this rock a little earlier than expected to provide a better loading ramp for barges to deliver a 50T drill rig. But we'll talk more about that in the next phase.

During the demolition phase, the interior of the dock area began its descent, about 24'. This elevation was the elevation needed for the subsequent phase. It did mean safety precautions, such as constructing safety fencing and establishing measures for preventing fall or fall on hazards.

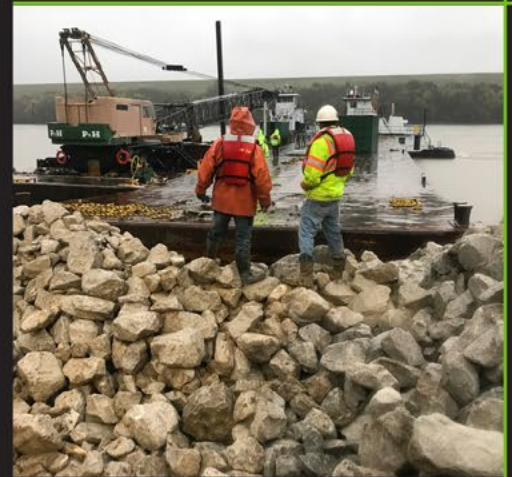
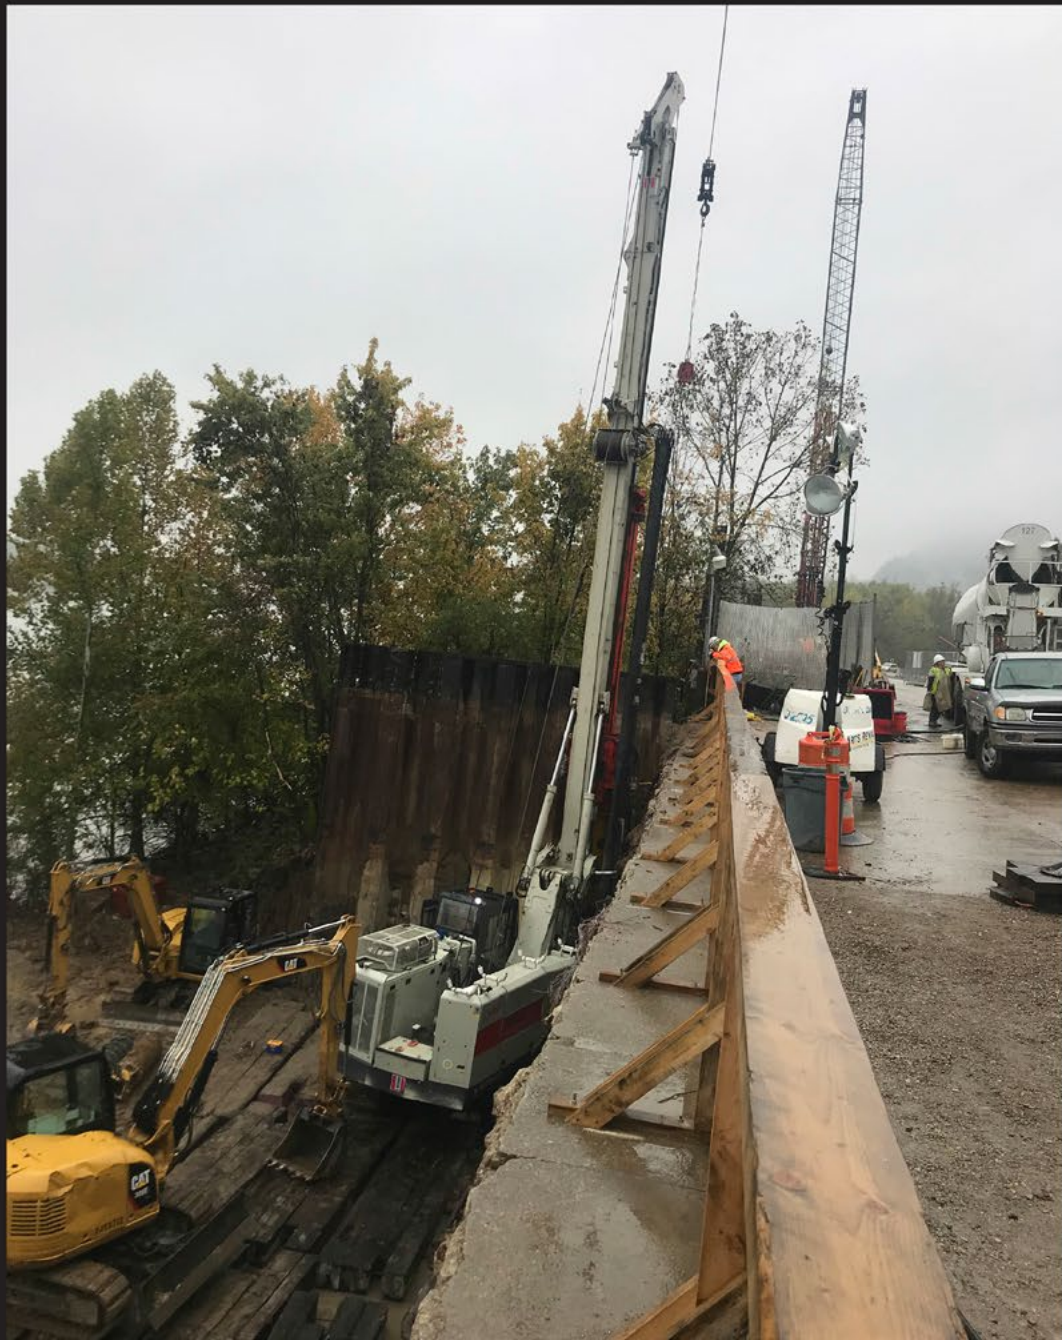
The drill rig was loaded at a nearby marina and floated down river and was carefully moored against the newly constructed, crushed stone pier we had built. Once the drill rig was in place, we began drilling the 70' (cir.) 24" drilled shafts. As we drilled the shaft, we used segmented casing to prevent the soils from collapsing. Once the soils were removed and we had a hollow shaft with 5-6' embedment in the weathered rock layer, we would install the H-pile from overhead with a 65T crane. Once the H-pile was in place, we would pump 8,000# grout into shaft, from the bottom up. At that point, the casing would be removed leaving in the ground a 24" drilled shaft with an H-pile in the center.

This system was just coming on line, with operations yielding 1 pile per day when the river forecast showed another flood in route. The Innovative Piering team kicked it into high gear, planning an exit strategy. It included establishing the last day that we had to be able to successfully abandon the drilling operation and make a speedy exit. This included multiple tug boats, barges and a marine crew supporting us from the river. It included crane support over head, assisting us with removal of drill tooling. And it took an aggressive action on part of the team to grade the beach adequately to time the barge deck aligning with the grade to allow us to track the drill rig back on to the barge. Unfortunately however, only 3 drilled H-piles were installed.

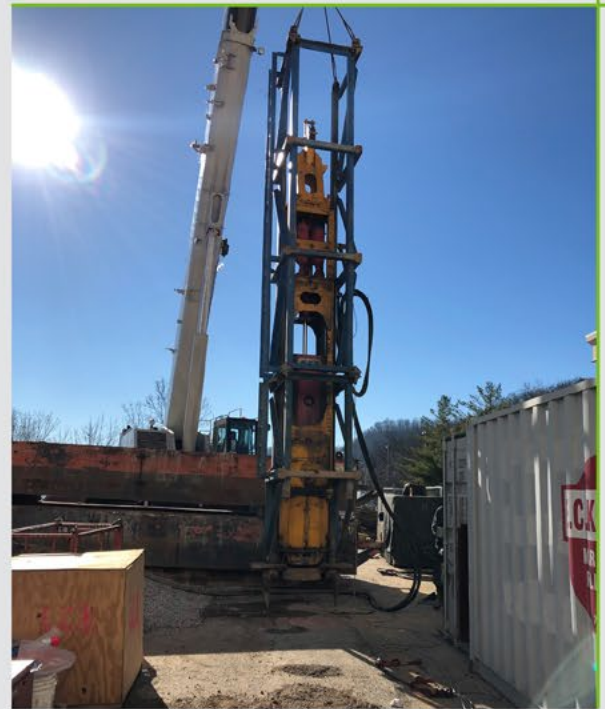
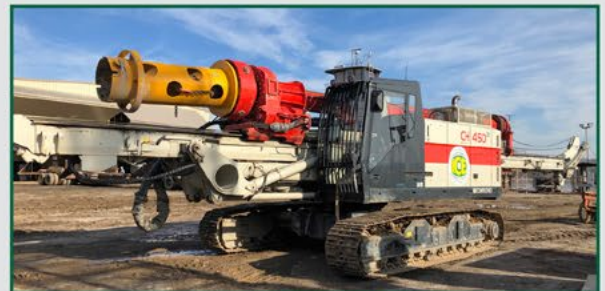
This did mean bringing in crane mats, a larger crane, vibrators and hammers, and installing the driven H-piles from the roadway. We were very conscious throughout this project to monitor the existing roadside wall. Tiltmeters had been installed from the first day of operations, setting a baseline and allowing us to remotely monitor any lateral movement in the roadside wall.

Continued river flooding made the H-piles driving challenging. Work was performed by smaller barges placed in the proposed loading dock area. The H-piles were fitted with rock biting tips, to prevent them from deflecting or walking. The 5' embedment criteria turned out to be successful and the remaining 11 piles were driven to final elevation.

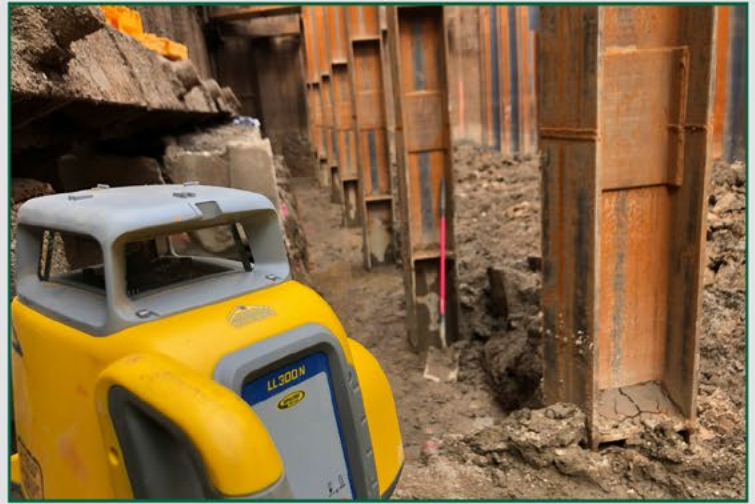
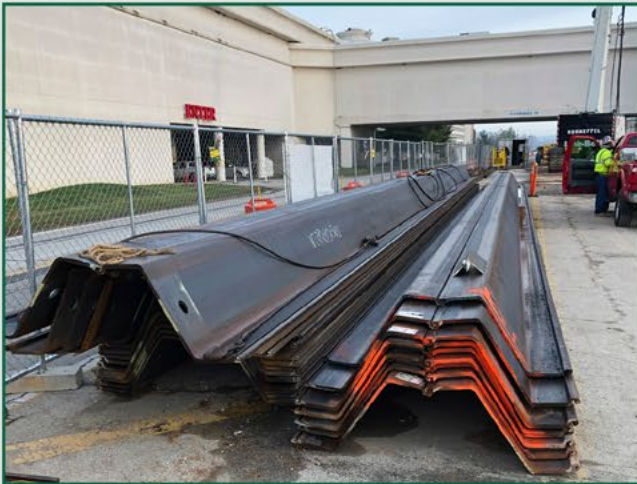
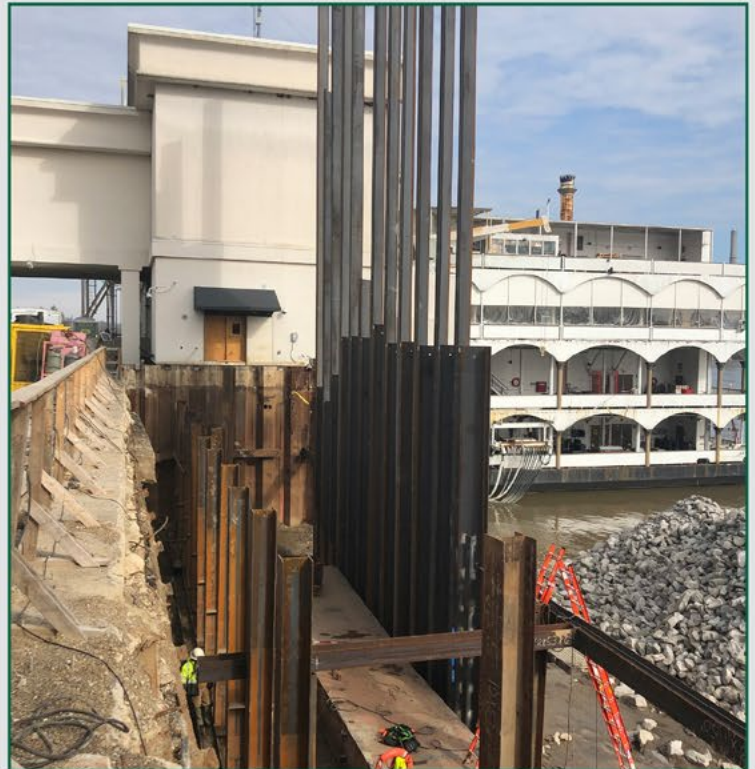
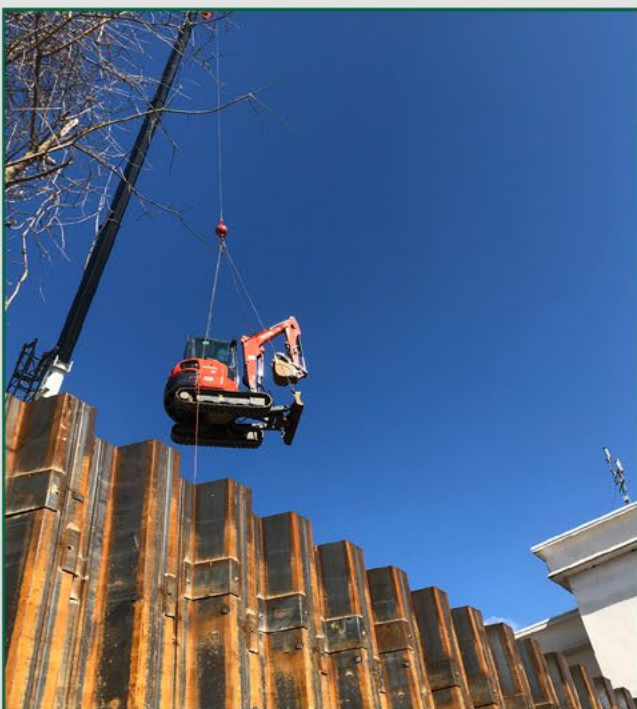
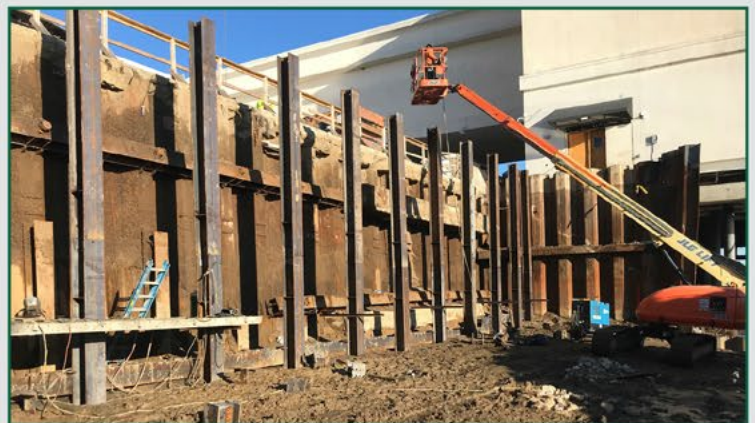
This next phase included sourcing heavy gauge, 79' steel sheet piles. Transportation and logistics were challenging, as was the spatial constraints on site in the lay down area. But falsework/ template material was installed and sheet piles were fitted with the rock bearing teeth, to prevent deflection or walking. Next up, the sheet piles were vibrated down to end bear on the weathered rock layer. Once the sheets were installed and end bearing, extensions were welded to bring the tops of the sheets to the final 'Top-of-Sheet' elevation. Again, all of this work had to be done from barge/platforms, as it was flooded majority of this phase.

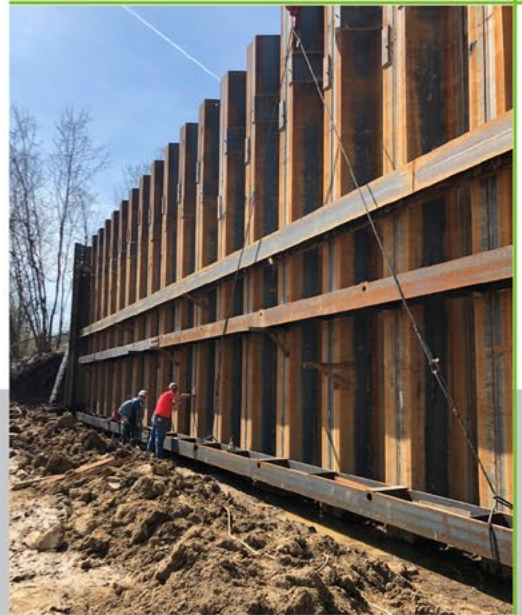
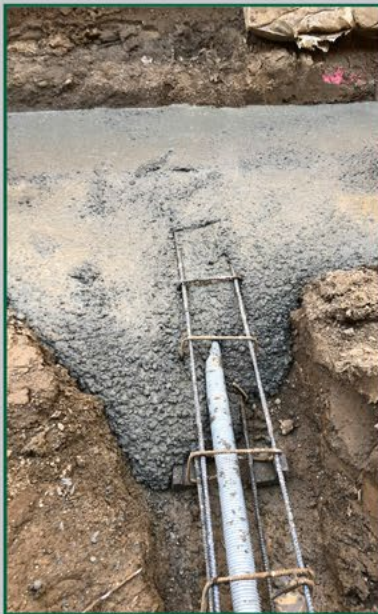
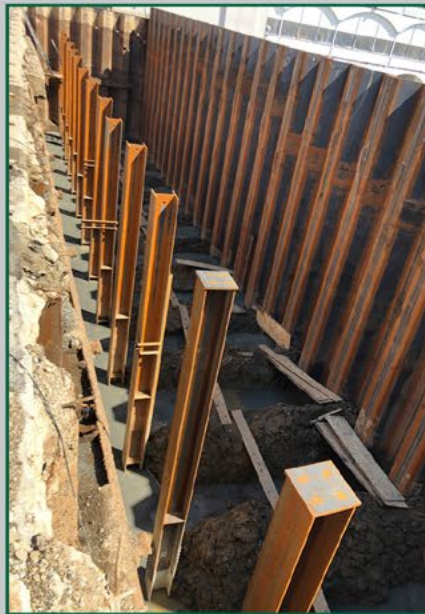
This phase was ensuring the new sheet pile retaining wall engaged the 14 H-piles that were previously installed. The design basically consisted of (2) rows (top and bottom) of waler & tension ties. Basically, as designed by the geo-structural engineers, a waler beam was installed on the back side of the H-piles, and the other waler beam was installed on the outside of the new sheet pile wall. Alignment was critical, as the waler beams were pre-manufactured offsite. This meant that final elevations and the East/West layout had to be about perfect in order for the tension ties to line up and the tension ties to be squarely loaded.

Once the waler beams were installed, and the tension ties connected the two waler beams, a steel reinforced concrete encapsulation occurred. Hundreds of cubic yards of 4,500 psi concrete was pumped and vibrated to fully encompass the steel tension ties, the waler beams and the steel reinforcement.

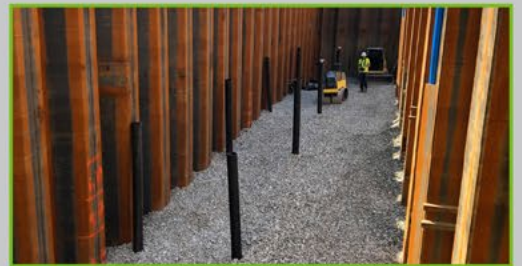
Our next priority was dealing with the drainage and the soil loading. We created a sloped bottom by pumping hundreds of cubic yards of a 150 psi flowable fill with 12" of fall toward the river. This gave us a strong bottom grade to evenly distribute the loads above and ensure water drained towards the river.

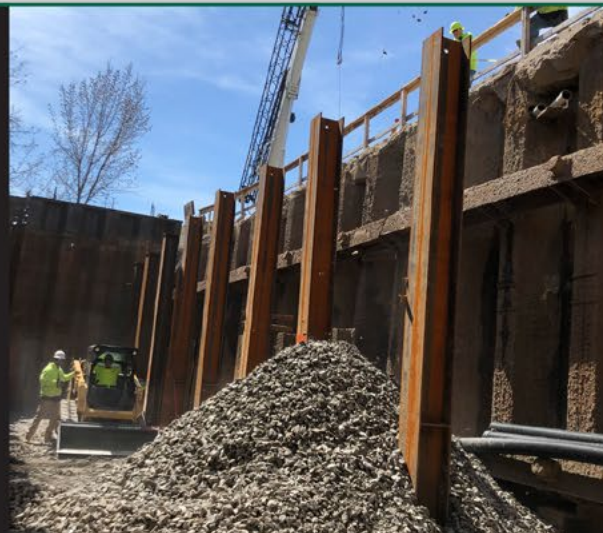
Once the flowable fill cured, we immediately set up a conveyor system to import the free draining, crushed stone. The stone would bed the pipe in place to ensure it was draining through the weep-holes in the sheet piles. For maintenance design, piping was installed vertical about every 18' to provide access for flushing of river sediment build up.

As the rock was placed, it would be graded in 12" lifts, and compacted with vibratory plate compactors around the edges, and sheeps-foot trench rollers/compactors and tracked equipment.

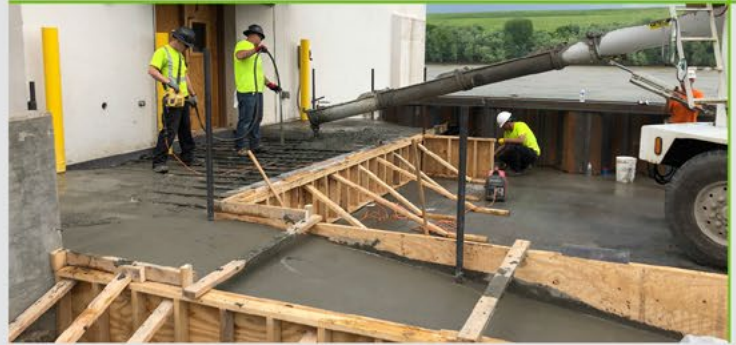
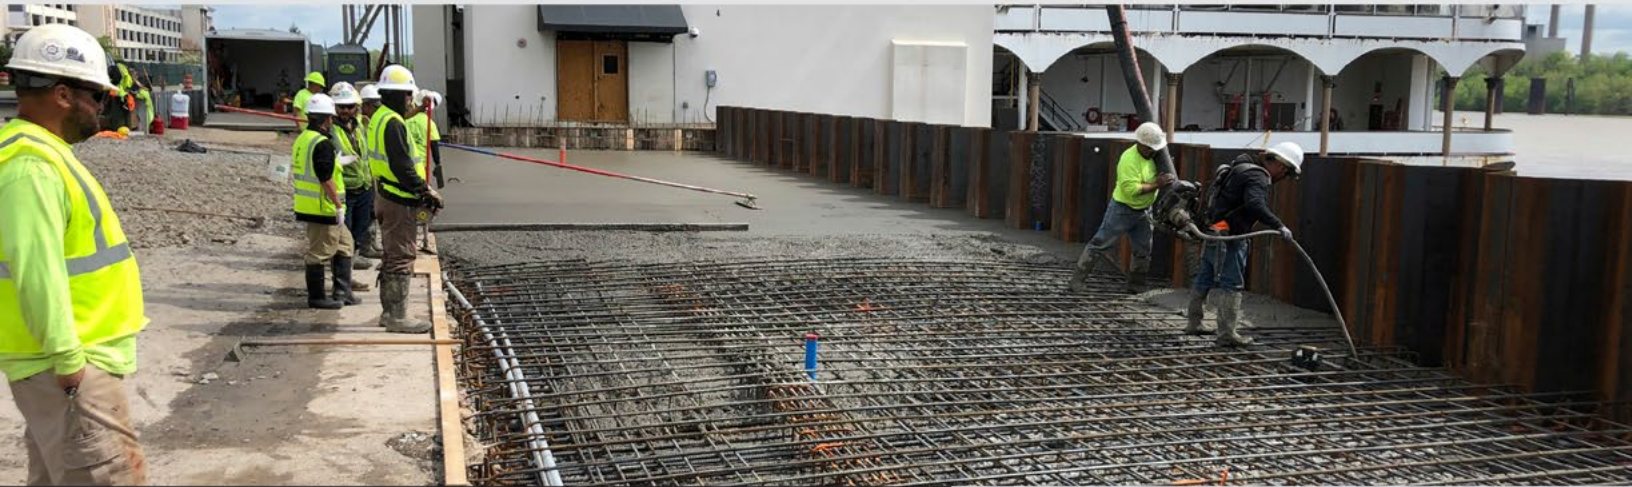
The last phase of this challenging project was wrapping up the top side. It included a 12" structural slab on grade, thickened edges, a grade beam and 35,000 pounds of steel reinforcement encapsulated. It also included a cast in place loading dock, boat mooring, stairs and a ramp. Hand rails and fencing were replaced and pavement was placed to ensure safe access.
